BUILDING 2020

CONDITION SURVEY DATA SHEET

CONDITION SURVEY

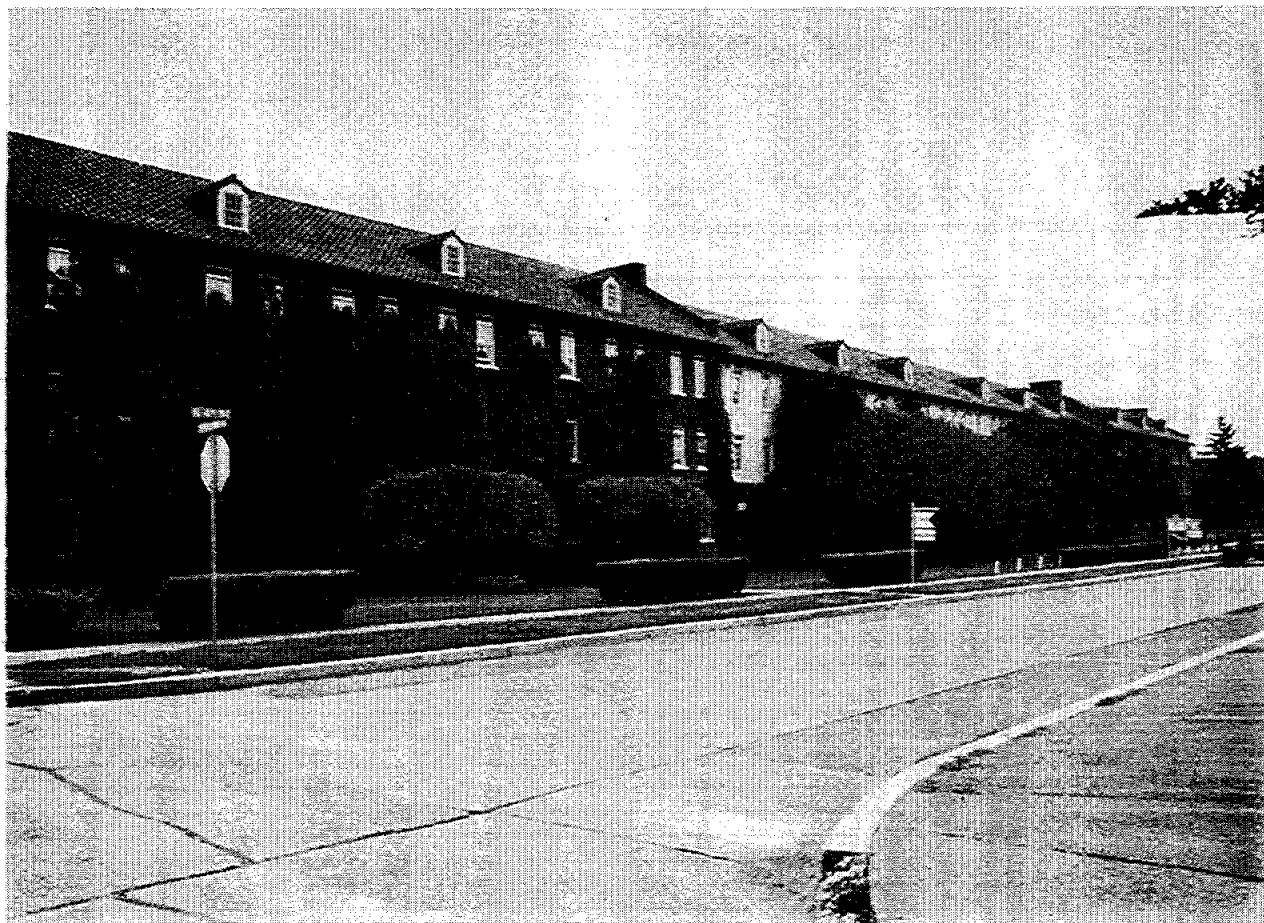
1987 PHOTO

The interior was completely remodeled in 1974 with new partition walls, drop ceilings, and doors. Only entry foyers and stairs remain as simple reminders of the original architecture. Most exterior doors, with the exception of main entries, were replaced with flush fire-rated units and most windows were replaced with vinyl units during the remodel; both of these changes, and the white-painted concrete steps, detract from the historic architectural character.
